INVESTIGATION ON ASPHALT ROADS WITHIN THE PORT OF DURBAN

O. Kunene ¹ and Dr. D. Allopi ²

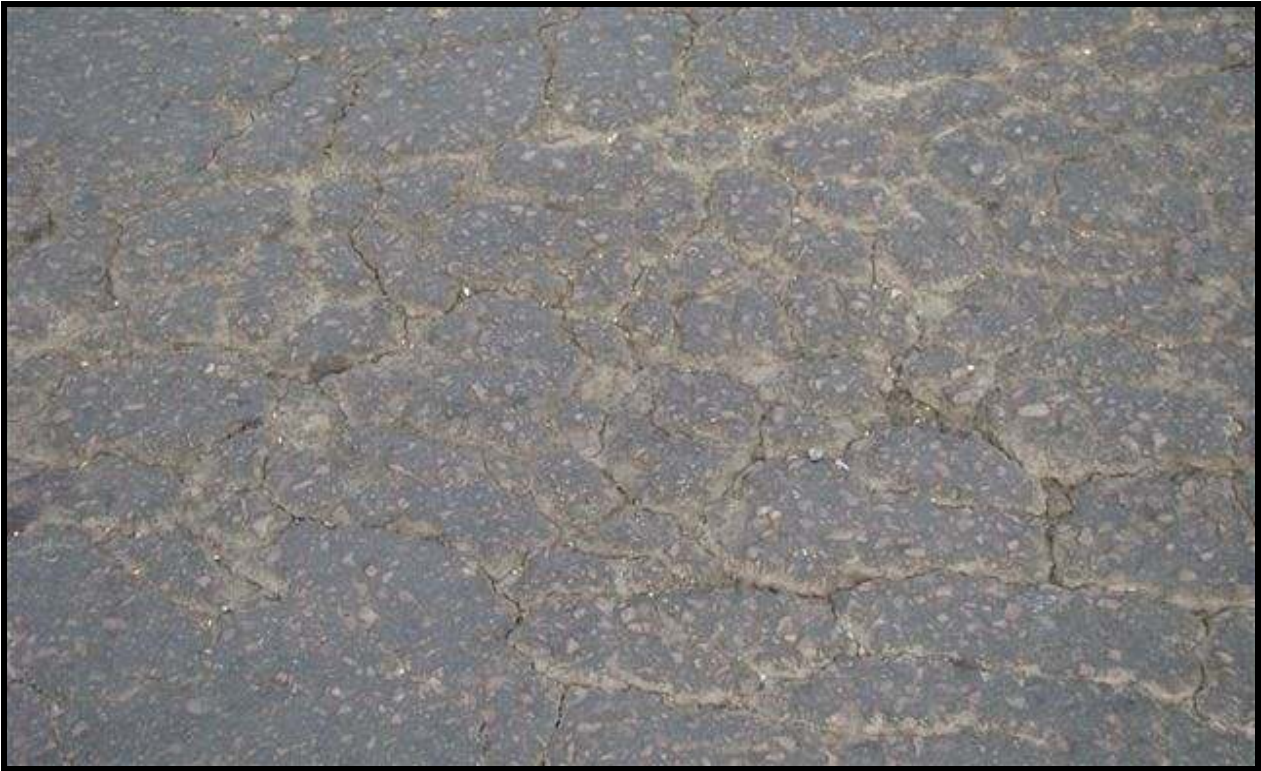
Figure 2 below shows the typical defects found on Maydon Road and most of these crocodile cracks are result of level crossings.

Figure 2: Crocodile cracks on Maydon Road

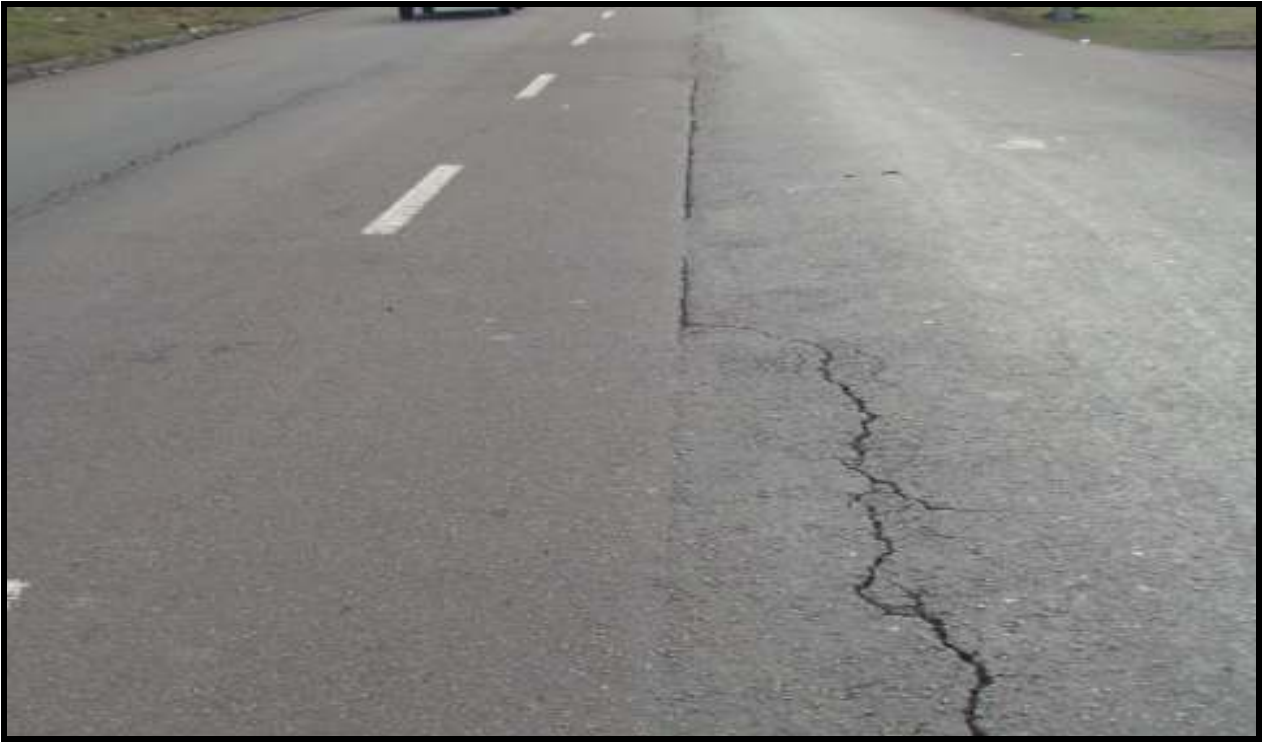
Figure 3: Longitudinal cracks on Bayhead Road

Figure 3 and Figure 4 show the type of asphalt defects observed during the assessment. Figure 3 above shows the longitudinal cracks found on Bayhead Road where the asphalt layer failed on the joint. Figure 4 below shows the depression on the asphalt layer found on Bayhead Road close to the intersection with South Coast Road.

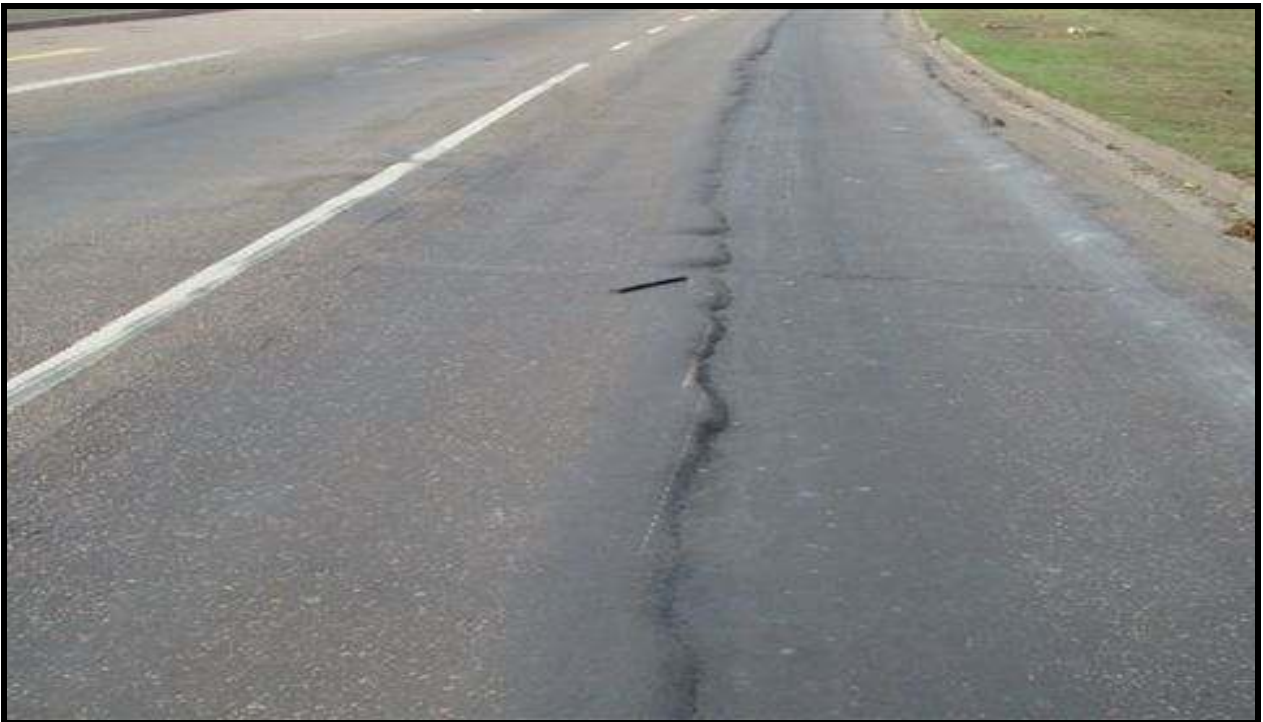
Figure 4: Depression on the asphalt layer on Bayhead Road

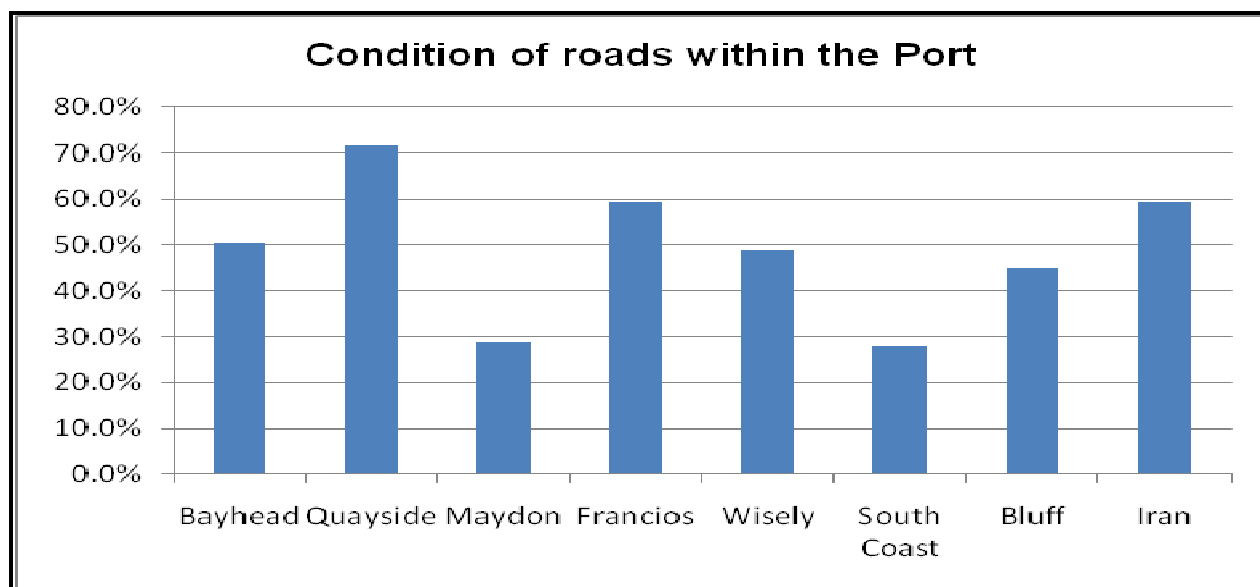
The results from the inspection reports conducted on the eight major roads within the Port are shown in Figure 5 below. Maydon and South Coast Roads are low rated roads which are in a poor condition. Quayside Road is high rated which is in a very good condition.

Figure 5: Assessment of road condition within the Port

- Quayside Road (71.5%) falls under B (very good) category. It looks like new and minor maintenance work may be required at a later stage.
- Francois Road (59.5%), Iran Road (59.5%) and Bayhead Road (50.5%) fall under C (good) category. It is moderate and maintenance work may be required within 12 months.
- Wisely Road (49%) and Bluff Road (45%) fall under D (fair) category. It is reasonable but maintenance work may be required within 6 months.
- Maydon Road (28.8%) and South Coast Road (28%) fall under E (poor) category. It is not safe and needs urgent attention.

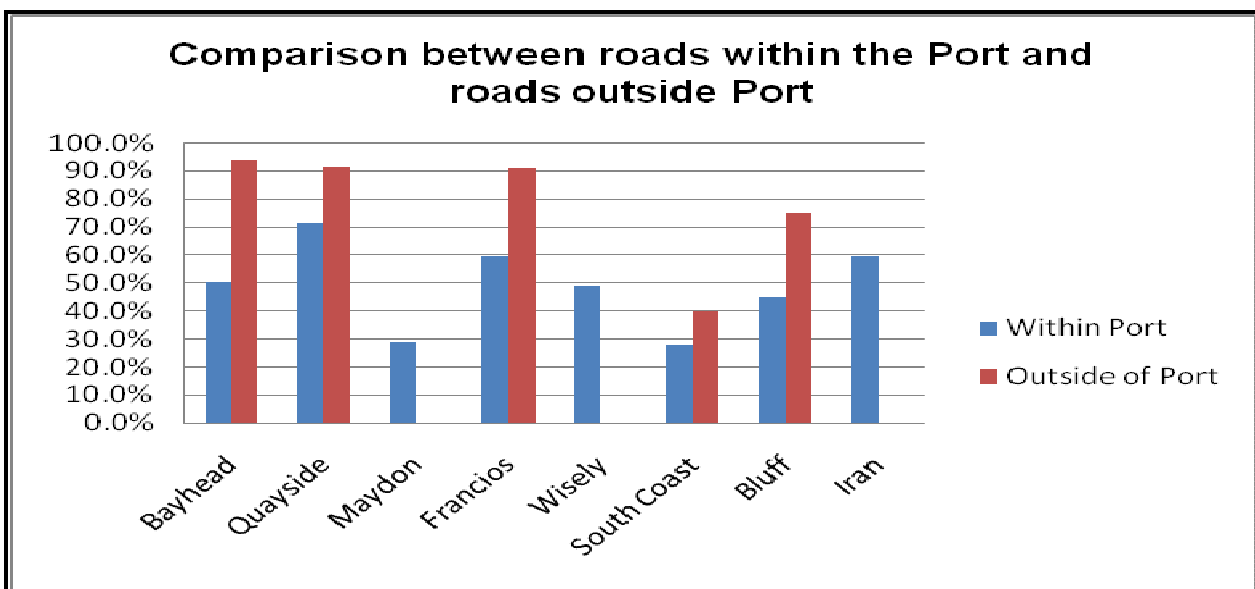
The section of roads which falls outside the Port are in a good condition compare to section of roads within the Port as shown in Figure 7 below.

Figure 7: Comparison between roads within and outside of the Port
 Source: eThekweni Municipality, 2010

- More attention must be paid in terms of regular inspections on roads within the Port in order to improve its standard to be similar to roads outside the Port.

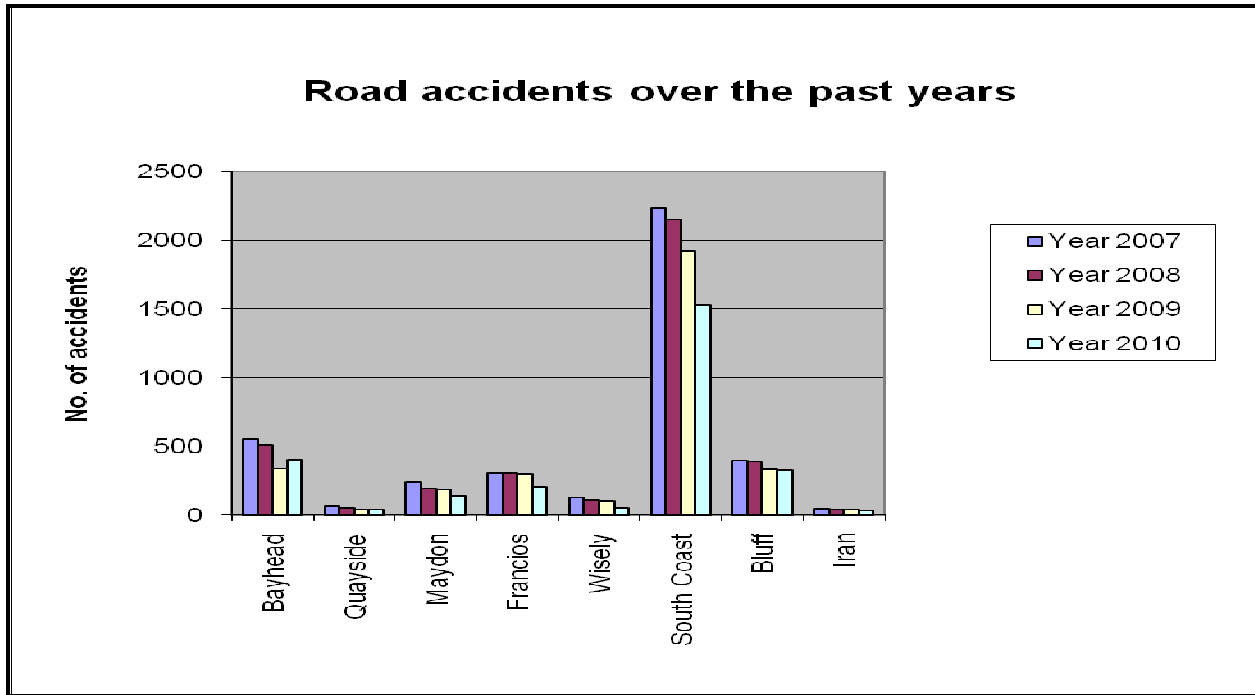
Over the past years the road accidents have decreased from 3972 in year 2007 to 2729 in year 2010. Figure 8 below shows that there has been a decrease in the number of road accidents over the past years although the number of deaths remain the same. South Coast Road had the highest number of accidents.

Figure 8: Road accidents over the past years
Source: eThekweni Municipality, 2010

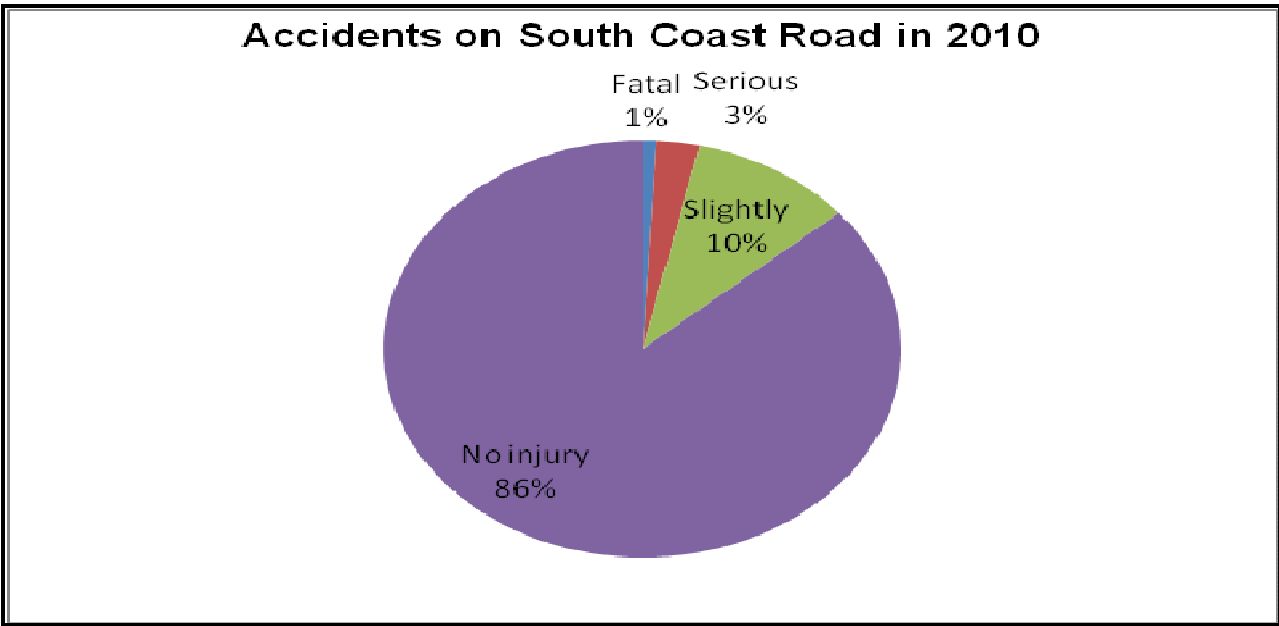
Figure 9 below shows that 1527 accidents happened in year 2010, there were 1318 (86%) people who came out with no injury, 155 (10%) people were slightly injured, 41 (3%) people were seriously injured and 13 (1%) had fatal injuries.

Figure 9: Road accidents on South Coast Road
Source: eThekweni Municipality, 2010

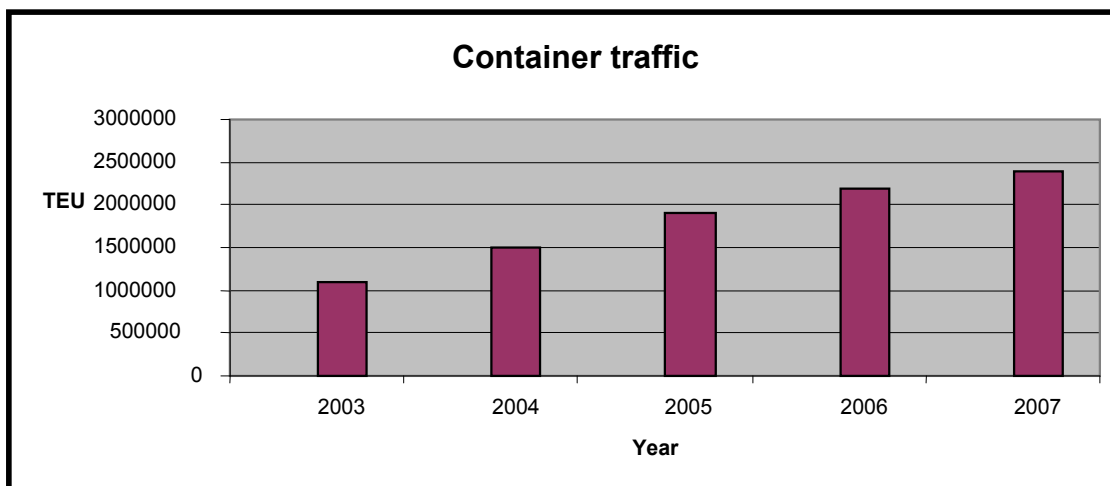
Figure 11: Container volumes at the Port of Durban
Source: Transnet Projects, 2007

Figure 11 shows the container volumes handled at the Port of Durban over the years where it increased from 1,1 million TEU in 2003 to 2,4 million TEU in 2007.
