IMPROVING RUNWAY SKID RESISTANCE AT KING SHAKA INTERNATIONAL AIRPORT THROUGH ULTRA-HIGH PRESSURE WATER-CUTTING

Wim Hofsink; MC Barnard and Piet Agema

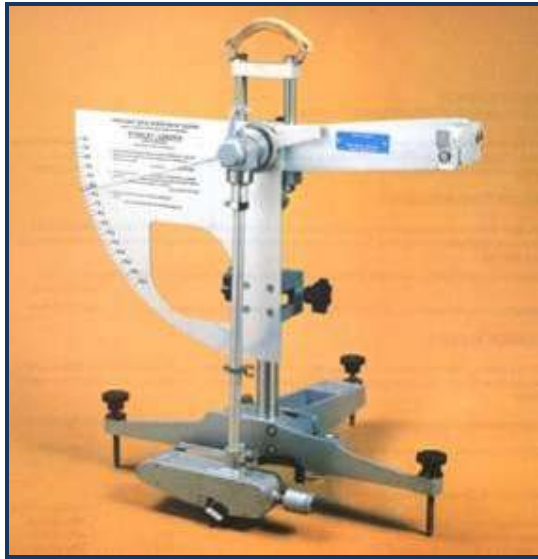
Micro-texture is normally measured by means of the British pendulum skid tester (BS 812) (see Figure 2) in terms of the polished stone value (PSV). The macro-texture of a surfacing has traditionally been measured by means of the sand patch test in South Africa. However, the Australasian developed sand circle (ASC) texture test (see Figure 3) has become popular in South Africa during recent years due to its short testing period and simplicity. In addition to these tests it has become the norm in South Africa to determine the macro-texture of a surfacing in terms of the Mean Profile Depth (MPD) by means of laser profilometer equipment such as the Dynatest Road Surface Profiler 5051, Mk11.

FIGURE 2 : PENDULUM SKID TESTER

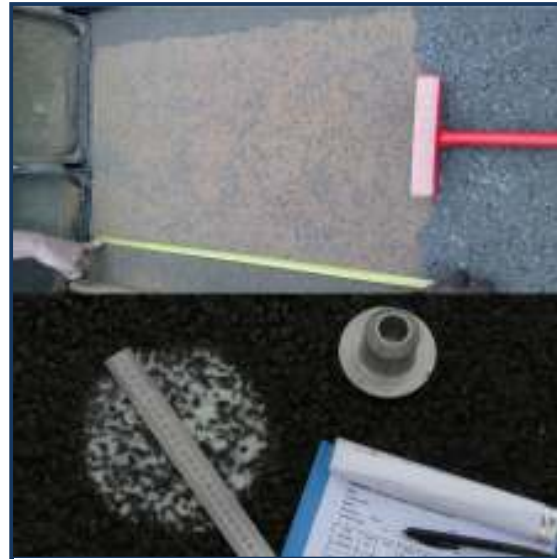
FIGURE 3 : SAND PATCH TEST AND ASC TEST

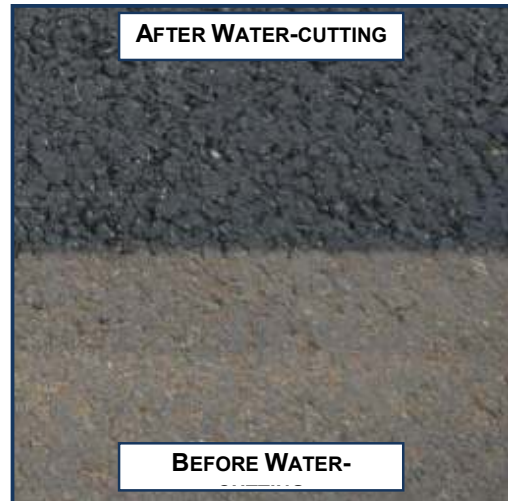
The UHP water-cutting process was developed to cut the uppermost surface using fine needles of water jetted at speeds of up to 1800 km/h, as illustrated in Figure 4 below. The fineness of the water jets results in the energy being dissipated on contact with the surface, allowing the bituminous mastic to be removed without stone loss and without increasing the permeability of the surfacing. Research (Waters and Pidwerbesky, 2008, p. 7) conducted on behalf of Land Transport New Zealand showed that water-cutting improves both the micro-texture of polished aggregates and the macro-texture of a surfacing, but it also exposes the micro-texture of the unpolished aggregates, resulting in improved skid resistance at both low and high travelling speeds as illustrated in Figure 5 below.

FIGURE 5 : EFFECT OF WATER-CUTTING ON TEXTURE

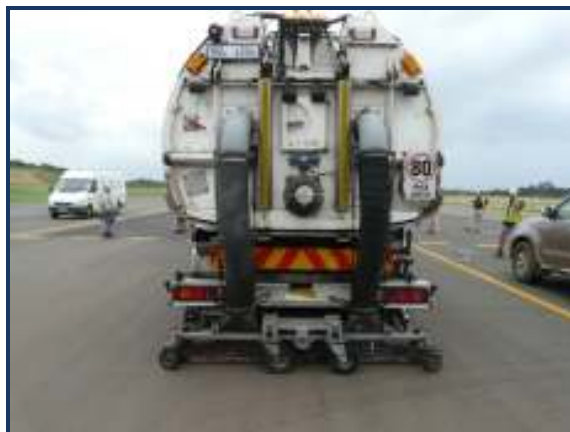
FIGURE 6 : BACKVIEW OF UHP WATER-CUTTER

The UHP water-cutting equipment includes variable pressure settings in order to allow the operator to remove less or more material as may be required. The removal of the bituminous mastic is achieved by means of the vacuum system and umbilical deckblaster (cutting head) attached to the ultra-high pressure water source. Figures 6 and 7 above shows the latest water-cutting equipment developed by Fulton Hogan Limited and imported to South Africa by Shisalanga Asphalt in Kwa-Zulu Natal.

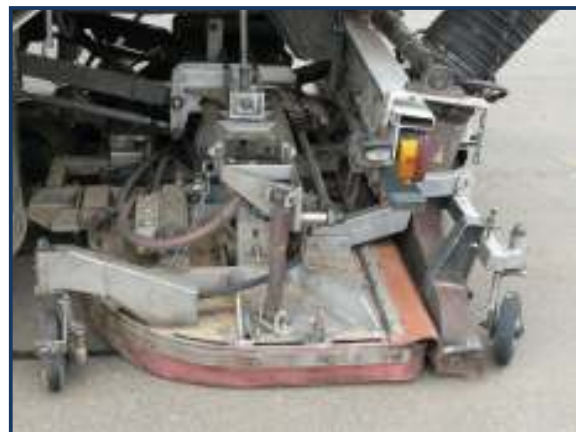
FIGURE 7 : VIEW OF UMBILICAL DECKBLASTER

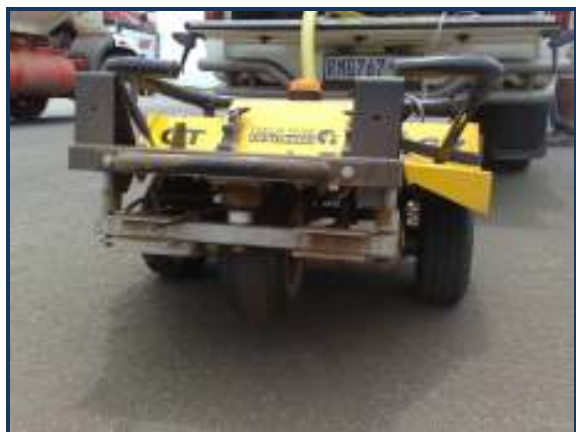
Paving of the 40 mm thick stone mastic asphalt (13.2 mm maximum aggregate size) wearing course commenced during August 2009 on Runway 06-24 from the 06-end. After the completion of the first 900 m of the centre strip (8 m wide), the skid resistance of the surfacing was tested by means of the Grip Tester Mk II. The equipment is owned by Specialised Road Technologies (Pty) Ltd and is frequently used by the ACSA to monitor the skid resistance of the pavements of its airports. It was decided to use the Grip Tester Mk II to undertake skid resistance measurements at KSIA to ensure uniformity in the method of assessing and reporting of runway and taxiway friction conditions. The results of the Grip Tester Mk II skid resistance testing are reported in terms of the Grip Number (GN).

FIGURE 8: VIEW OF GRIP TESTER

On 24 November 2009 the engineering team re-evaluated the skid resistance and macro-texture of the cleaned runway, using the Grip Tester and the Dynatest Road Surface Profiler 5051, Mk11 respectively (see Figures 8 and 9 above). Sand patch tests were also conducted on the SMA surface. The contractor was also asked to prepare an area on the parallel taxiway where the binder film of the SMA wearing course was removed by means of sand blasting to simulate the expected surfacing condition after traffic. The skid resistance testing yielded results above the recommended MFL-value, but mostly lower than the maintenance planning level (MPL). The sand patch tests conducted on the cleaned runway yielded results in macro-texture varying between 0.6 mm and 0.8 mm.

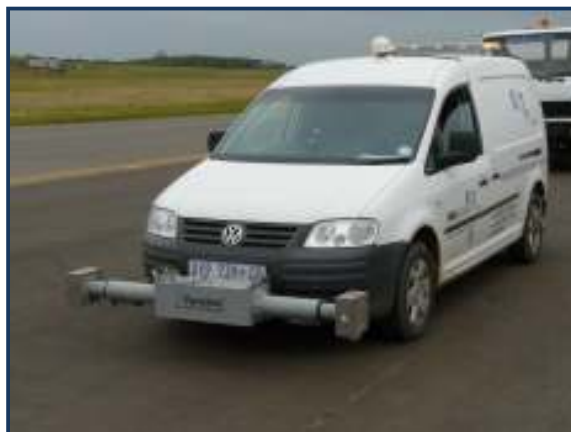
FIGURE 9: VIEW OF DYNATEST ROAD SURFACE PROFILER

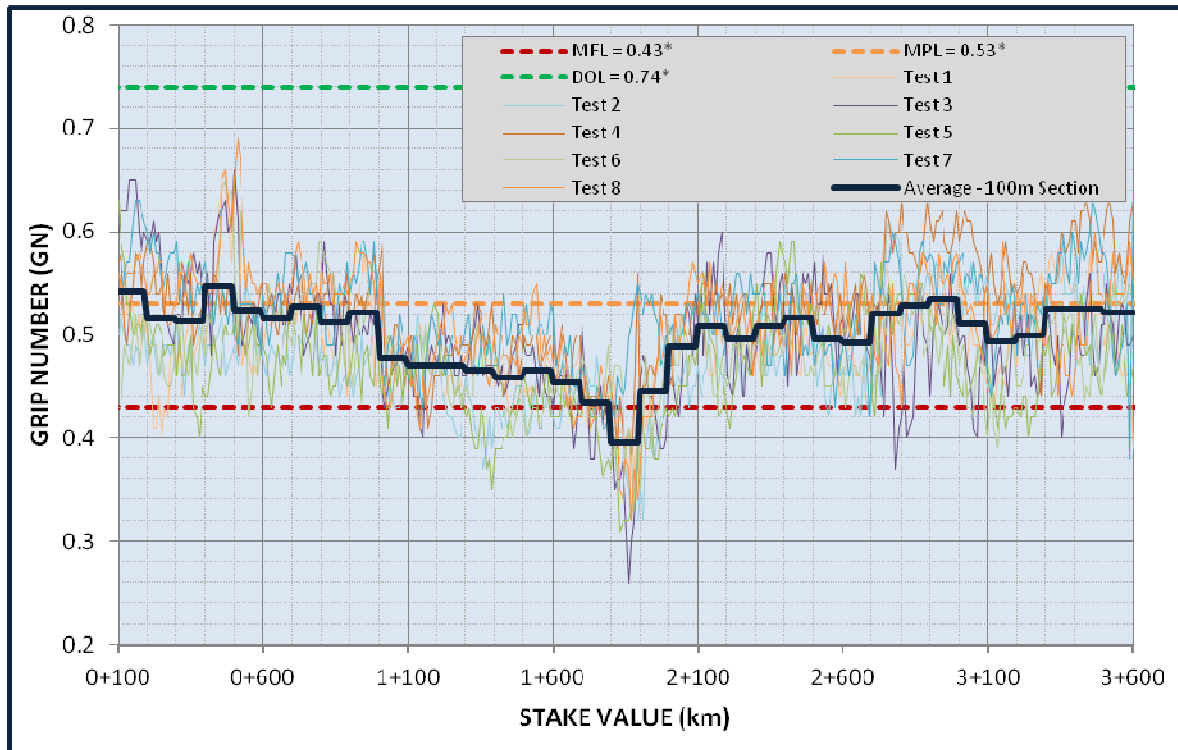
Figures 10 and 11 below summarise respectively the Grip Tester and Road Surface Profiler results for the various runs conducted along the runway. The 100 m section in the middle of the runway was not cleaned and still contained dirt as a result of a temporary haul road crossing.

FIGURE 10 : SKID RESISTANCE TEST RESULTS OF CLEANED RUNWAY SURFACE

It was concluded that the UHP Water-cutter improved the skid resistance, as measured with the Grip Tester from a level below Maintenance Planning Level (as illustrated by Figure 10) to a level above the Design Objective Level of 0.74 at a speed of 65 km/h, resulting in full compliance with the ICAO Annex 14 recommendations for new runways.

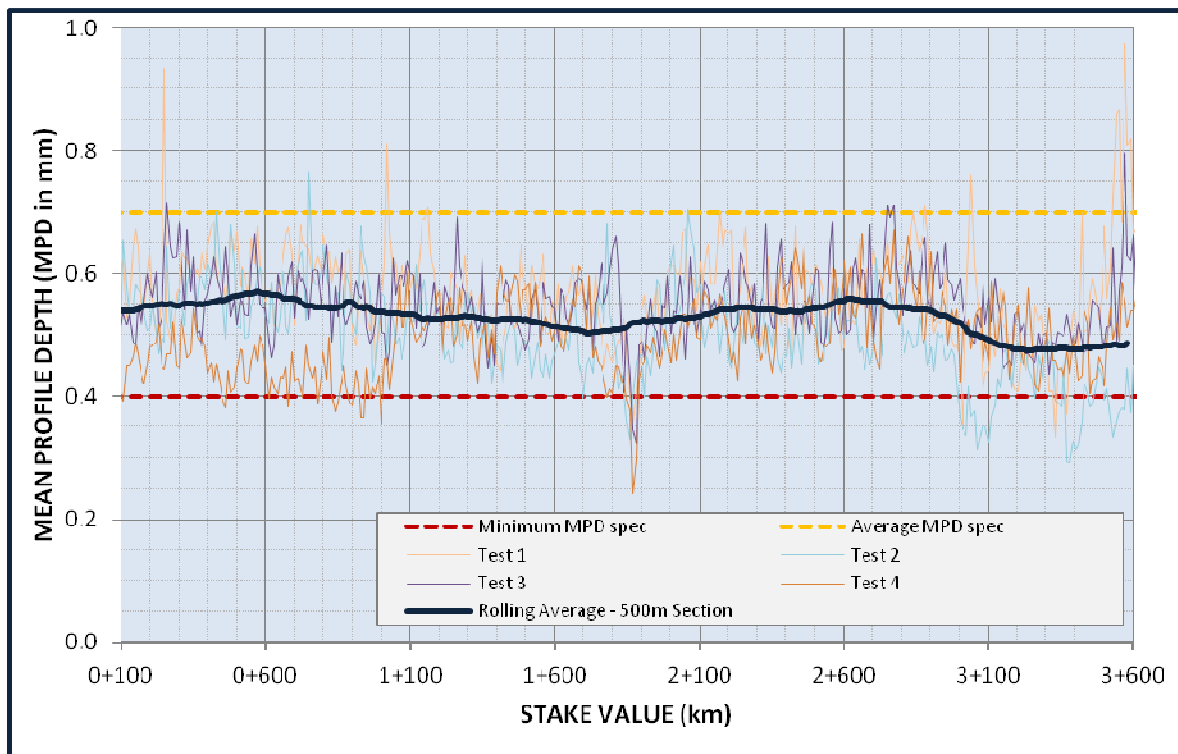
FIGURE 11 : DYNATEST ROAD SURFACE PROFILER MEAN PROFILE DEPTH TEST RESULTS

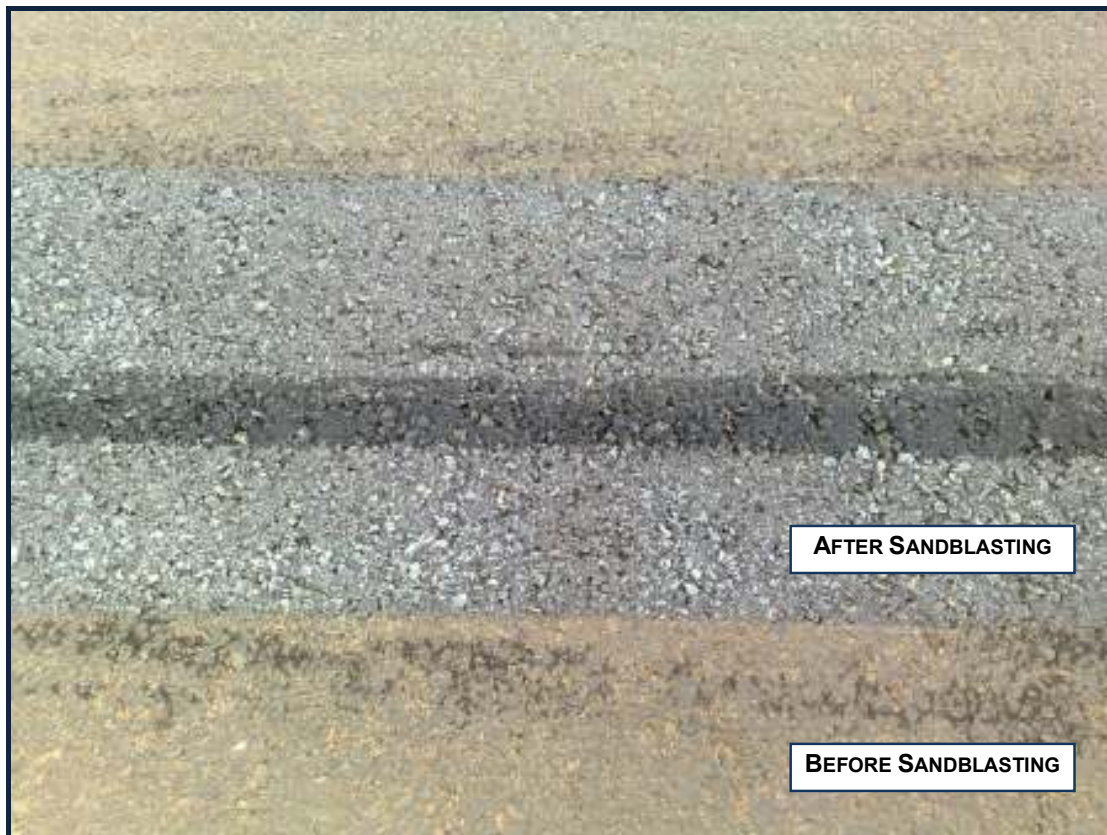
In contrast with these test results the tests conducted on the strip which was cleaned by means of light sand blasting yielded excellent results with the average GN = 0.81 at 65 km/h, indicating that removal of the binder film from the surface of the wearing course could address the problem. Figure 12 below shows the effect of the sandblasting on the surface texture. However, the sandblasting did not address the ICAO Annex 14 recommendation in respect of a minimum macro-texture of 1.0 mm, as the macro-texture measurements recorded with the Road Surface Profiler varied between 0.7 mm and 0.8 mm Mean Profile Depth (MPD).

FIGURE 12 : EFFECT OF LIGHT SANDBLASTING ON THE SURFACE TEXTURE OF THE SMA WEARING COURSE

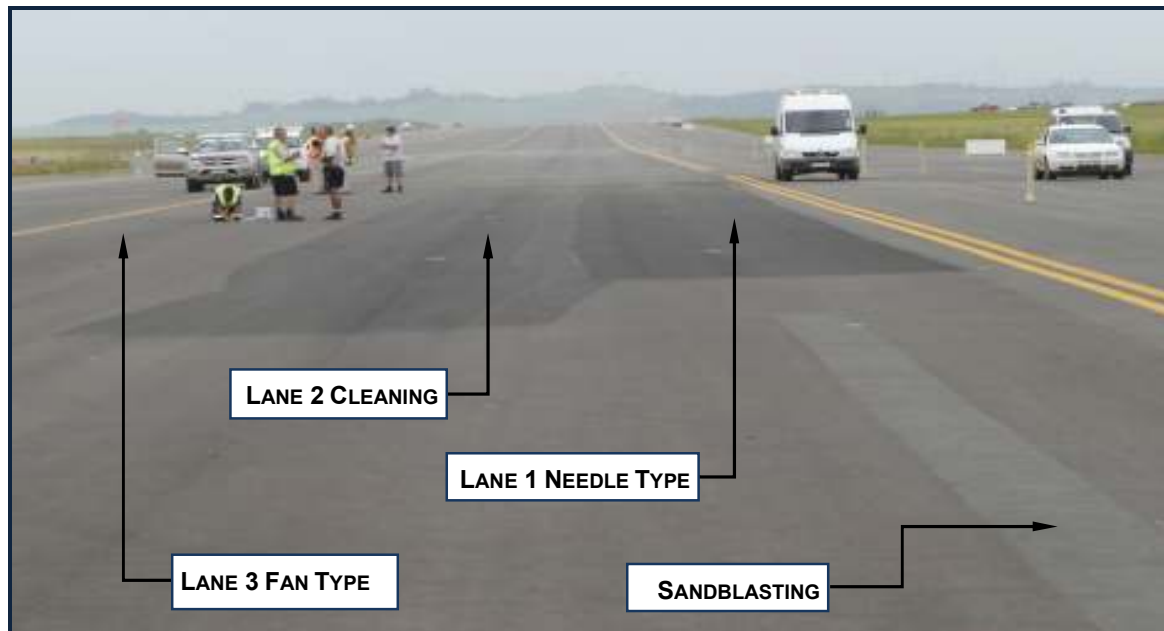
FIGURE 13 : VIEW OF WATERCUTTING TRIAL SECTION, SHOWING LANE DISTRIBUTION

The UHP water-cutting trial section was conducted 03 March 2010 to determine the speed and pressure applications to implement a macro-texture of 1.0 mm without damaging the surface integrity. Three lanes of 3.5 m width were prepared at different speeds and pressures, with the trial section illustrated in Figure 13 above. The sandblasted strip is also shown in Figure 13 above.

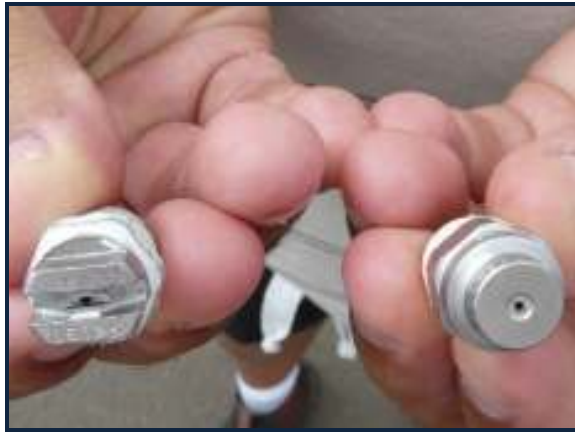
- Lane 1 was treated with a mild water-cutting application at 400 bar pressure with a needle type water jet (see Figure 14) at a travelling speed of 3.5 m/min;
- Lane 2 was treated using only washing and vacuuming the surface to clean it of dust and sand by water jetting at 200 bar without cutting at a travelling speed of 4.5 m/min; and
- Lane 3 was treated using a mild water-cutting application at both 500 bar and 600 bar with a fan / dovetail type jet (see Figure 14) at a travelling speed of 3.5 m/min.

FIGURE 14 : COMPARISON OF WATER JET TYPES

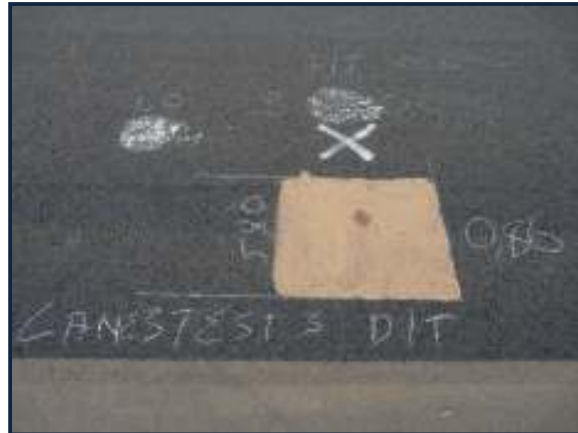
Skid resistance and macro-texture testing was conducted prior to and after water-cutting. These test results are compared in Table 2 below for the different water-cutting applications. Figure 15 shows the comparable test results obtained from the sand patch test and the ASC test. This comparison provided confidence in implementing the ASC test for process control purposes, with the two tests yielding similar results for all the areas.

FIGURE 15 : COMPARISON OF MACRO-TEXTURE TEST

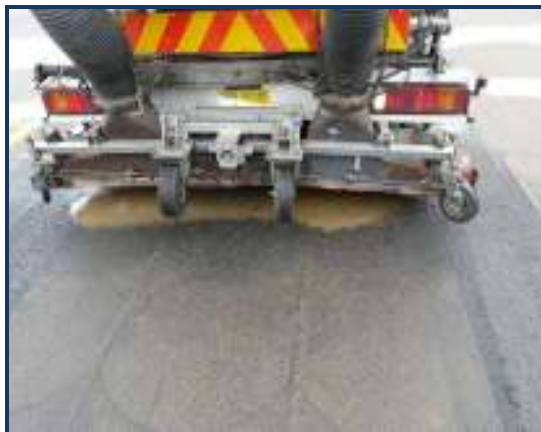
The water jetting cleaning treatment on Lane 2 yielded a muddy sludge as illustrated by Figure 16, with Figure 17 showing the water-cutter in action during the treatment of Lane 1. The high-pressure cleaning and vacuuming treatment on Lane 2 improved the ASC measured macro-texture of the SMA wearing course from 0.5 mm to 0.7 mm on average.

FIGURE 16 : MUDDY SLUDGE EXTRACTED ON LANE 2

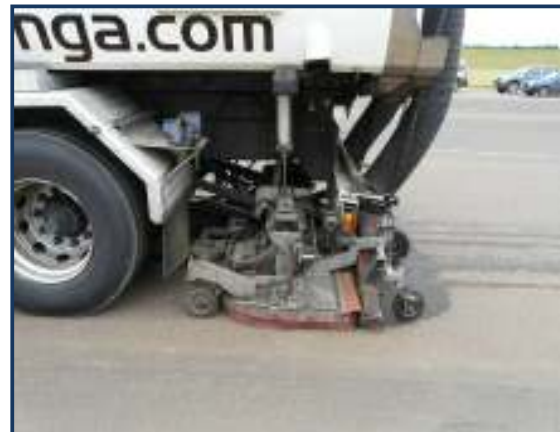
FIGURE 17 : START OF OF LANE1 WATER-CUTTING

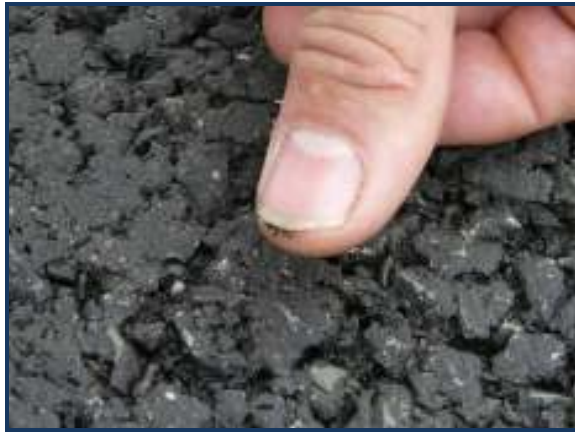
instead of the needle jet. This led to the test on Lane 3 in which the necessary pressure was determined to achieve the ICAO Annex 14 recommended macro-texture of 1.0 mm. The recommended value was achieved at a water pressure of 600 bar with the dovetail jet. Unlike the surface of Lane 1, which was watercut with the needle jet, the bituminous binder was not entirely stripped from the aggregates as is illustrated by Figure 18 below.

FIGURE 18 : VIEW OF WATER-CUT MACRO-TEXTURE

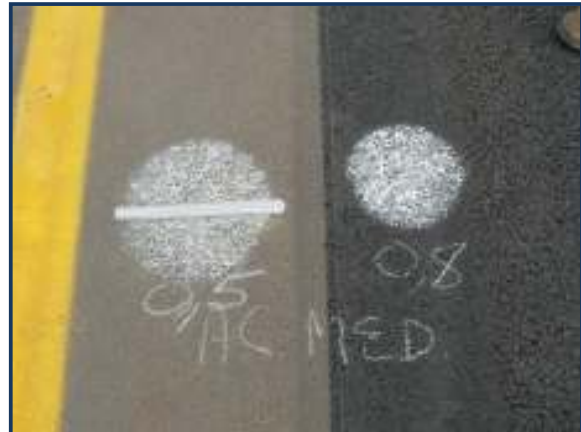
The water cutting in Lane 1 extended over the joint between the SMA wearing course of the taxiway travelway and the medium continuously graded HMA wearing course of taxiway shoulder, as illustrated by Figure 19 below. The ASC comparative testing revealed that even for the continuously graded asphalt a significant improvement in the macro-texture is achieved by means of the water-cutting, with the texture depth increasing from 0.5 mm to 0.7 mm.

FIGURE 19 : TEXTURE IMPROVEMENT OF AC MEDIUM

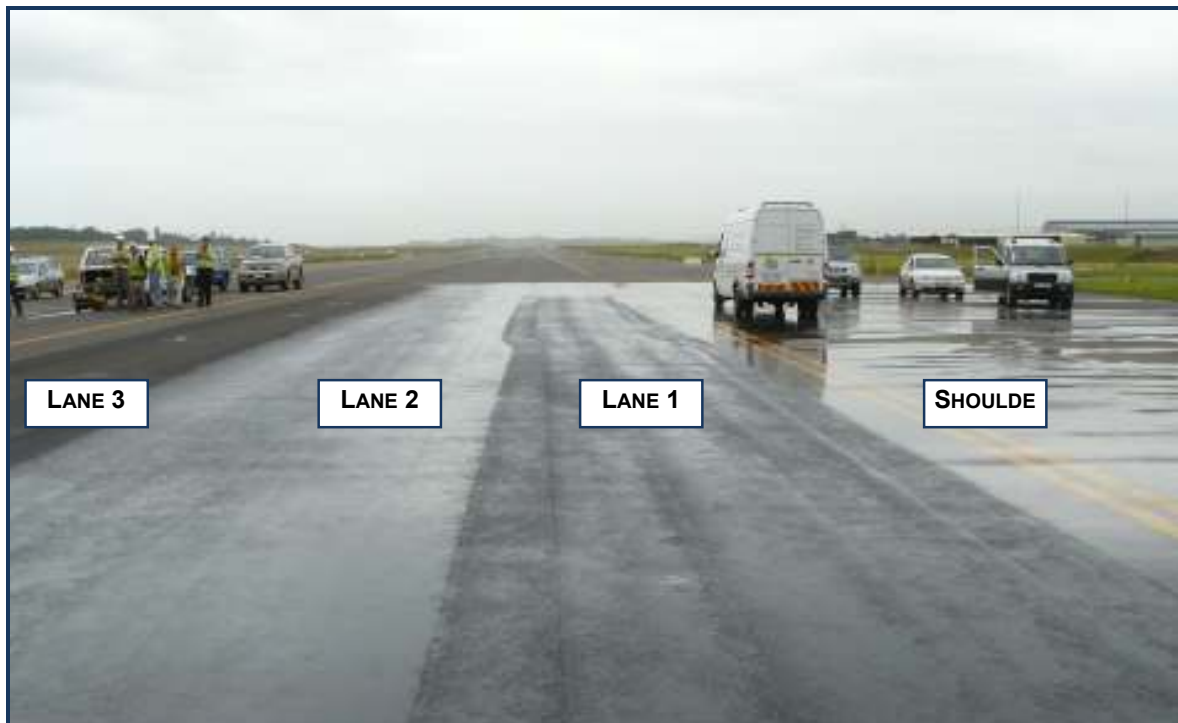
After all testing was concluded, the area was flooded with water from a water browser to observe the impact of the water-cutting upon the surface drainage. This experiment showed that the run-off flow increased significantly, confirming that the improved macro-texture will ensure better wet-weather performance of the runway. The photo pertained in Figure 20 below was taken moments after the water was sprayed on the test section, with the water-cut areas of Lanes 1 and 3 appearing much drier than the washed Lane 2 and the shoulder area without water-cutting.

FIGURE 20 : WATER RUN-OFF EXPERIMENT

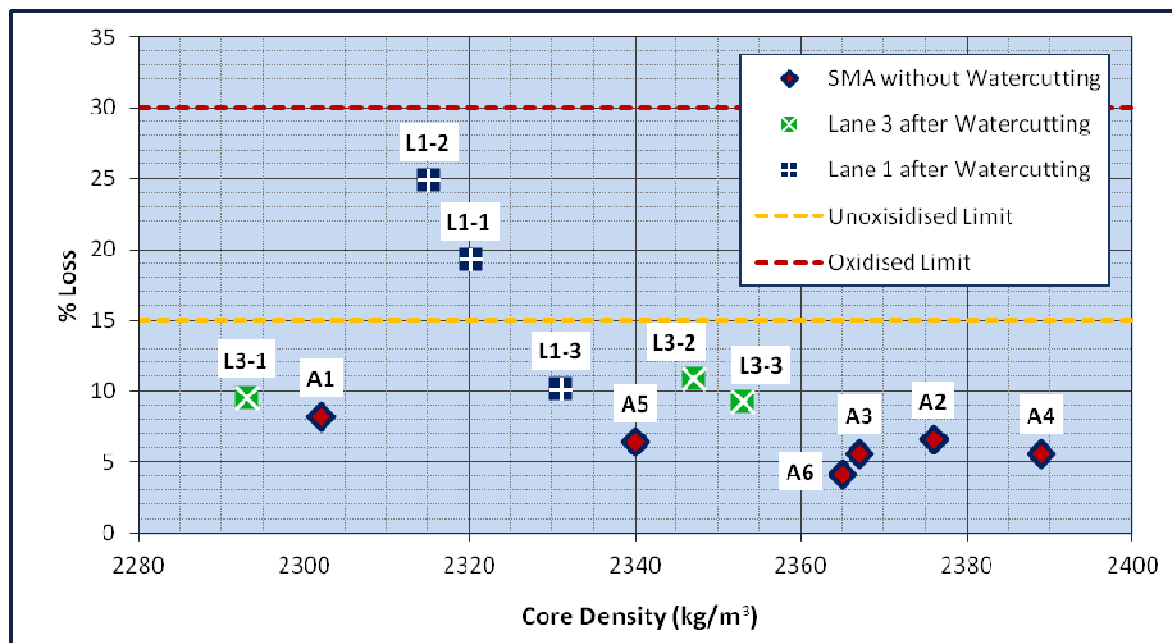
6.08%. The listed findings are presented graphically in Figure 21 below. The results indicate that the durability of the SMA surfacing was affected more severely by the needle nozzle water-cutting than the dovetail nozzle water-cutting as the increase in weight loss of these samples were significantly more than the average % loss of the untreated samples. It should also be noted that in general the lower core density resulted in higher % loss during the Cantabro Abrasion test.

FIGURE 21 : CANTABRO LOSS VS CORE DENSITY

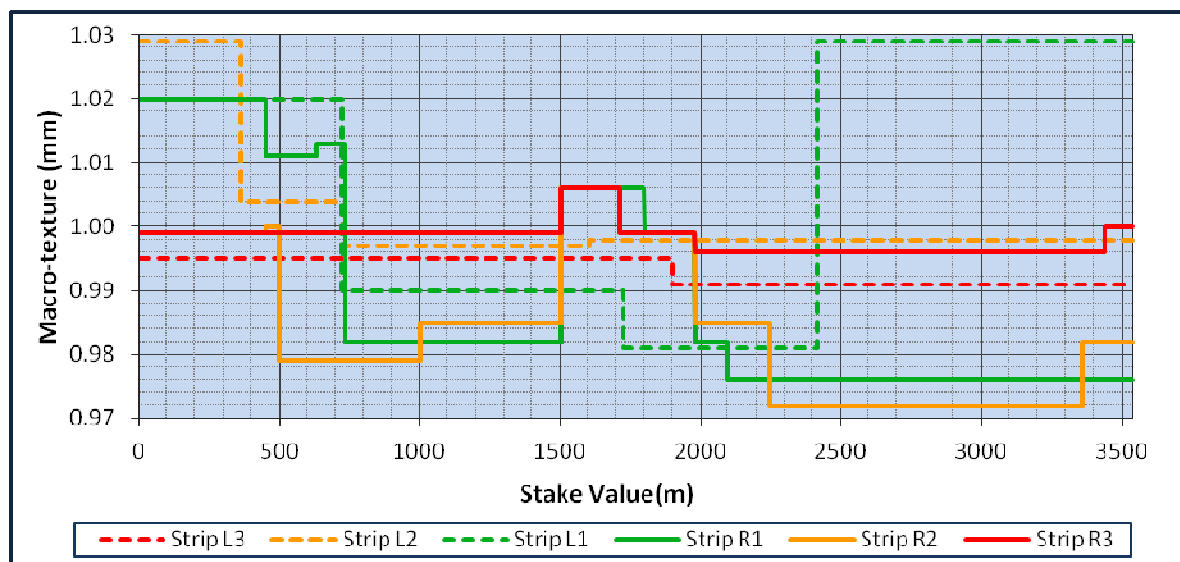
The monitoring was done using the Australian Sand Patch method and the results of the measurements are summarised in Figure 22 below. An average macro-texture of 0.998 mm was achieved, with a minimum value of 0.972 mm. The UHP water-cutting therefore resulted in the macro-texture of the runway being compliant with the ICAO Annex 14 recommendation. The figure also indicates the length of water-cutting applied for each 3.0 m wide strip per day, as the average texture depth for each work section is plotted.

FIGURE 22 : SUMMARY OF MACRO-TEXTURE MEASUREMENTS AFTER UHP WATER-CUTTING

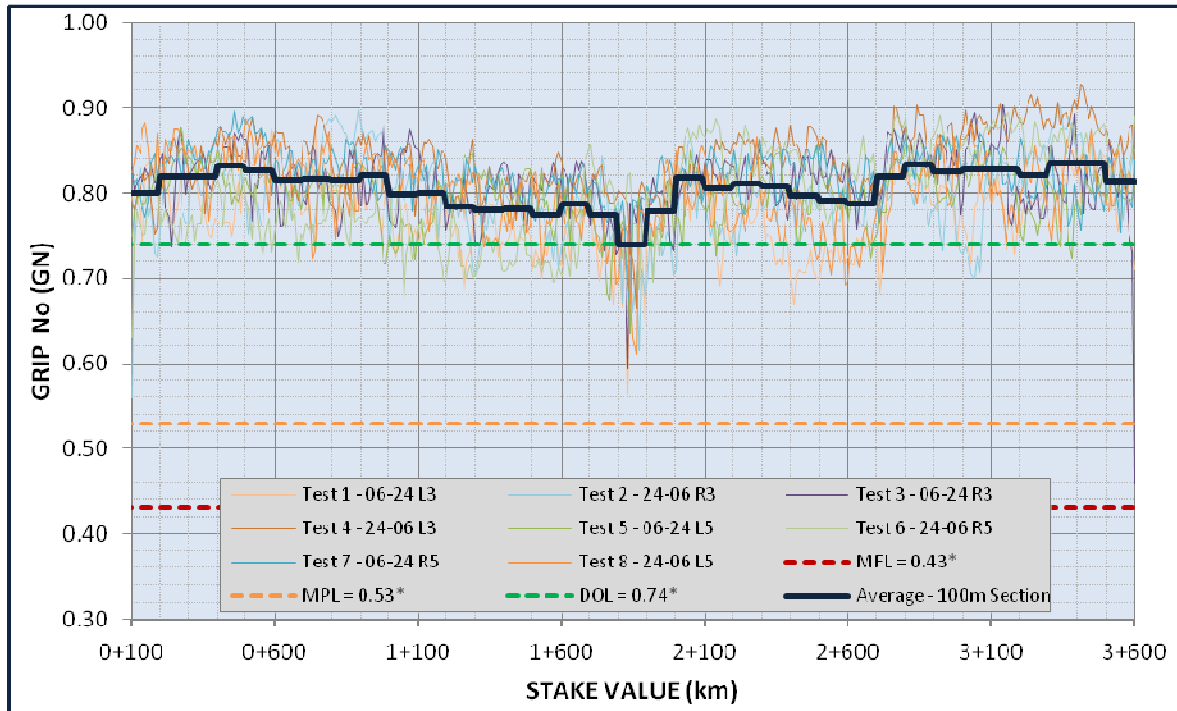
The skid resistance of the runway was tested by means of the Grip Tester at offsets of 3.0 m and 5.0 m on both sides of the centreline in both directions, resulting in a total no of eight tests. The results of these tests are summarized in Figure 23 below.

FIGURE 23 : SUMMARY OF GRIP TESTER RESULTS AFTER UHP WATER-CUTTING OF COMPLETE RUNWAY
